City of Gloversville

Downtown Revitalization

Building Re-use Analyses

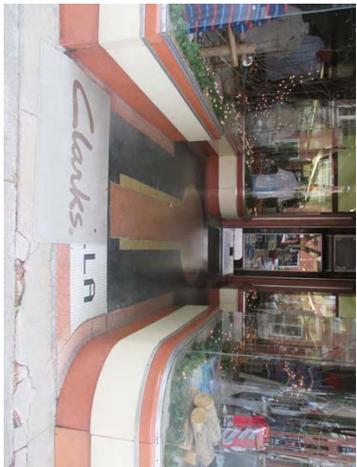
Dundaj's recessed entryway.

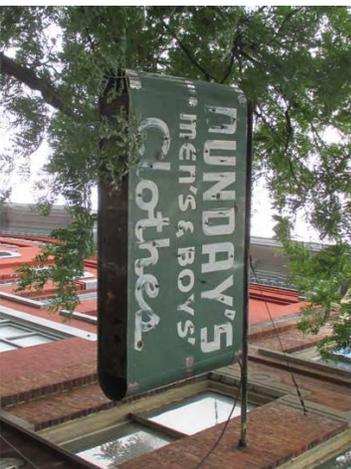
Current condition of historic blade sign.

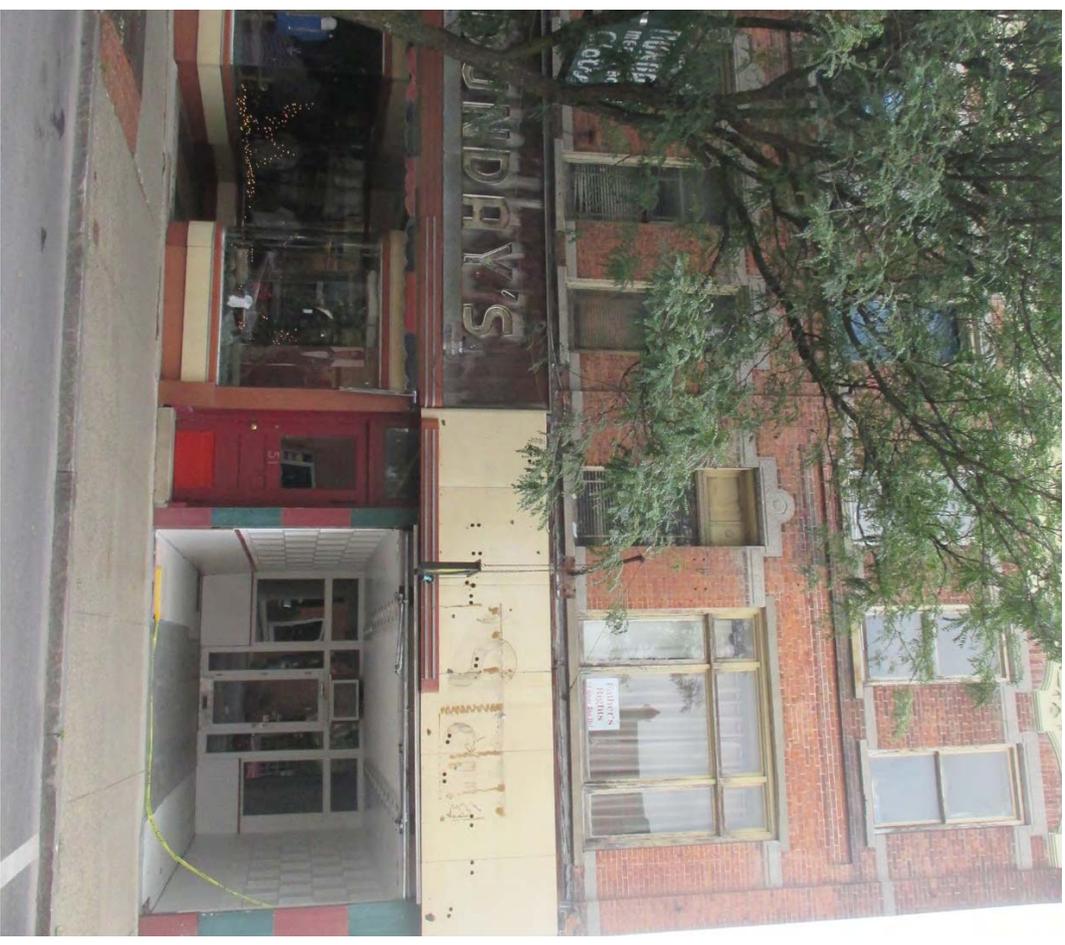
Current condition of storefronts.

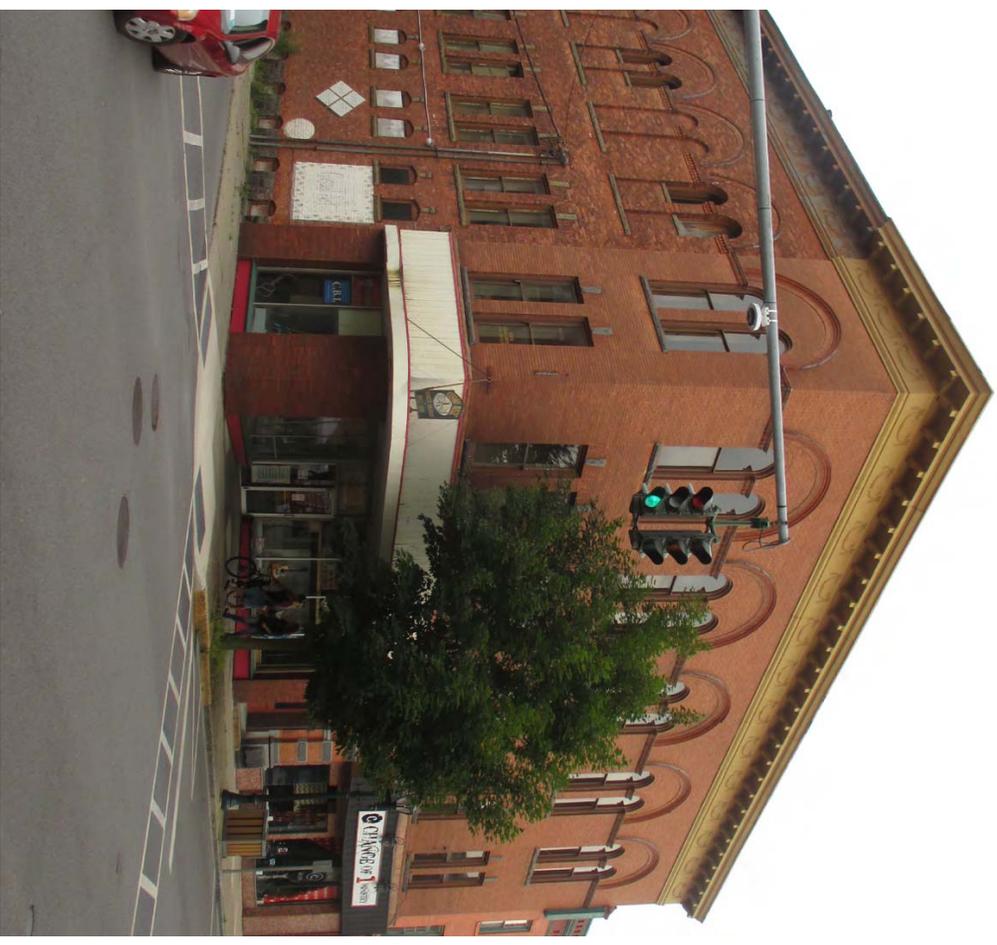
Current condition of exterior

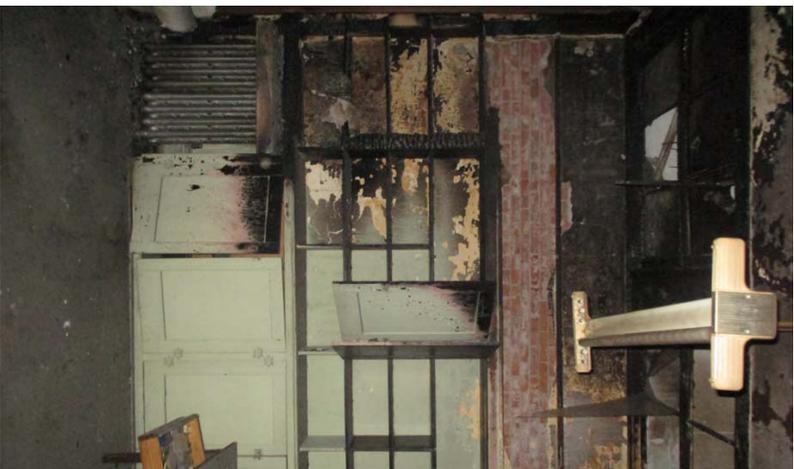
Signs of fire damage on built in shelving/ceiling.

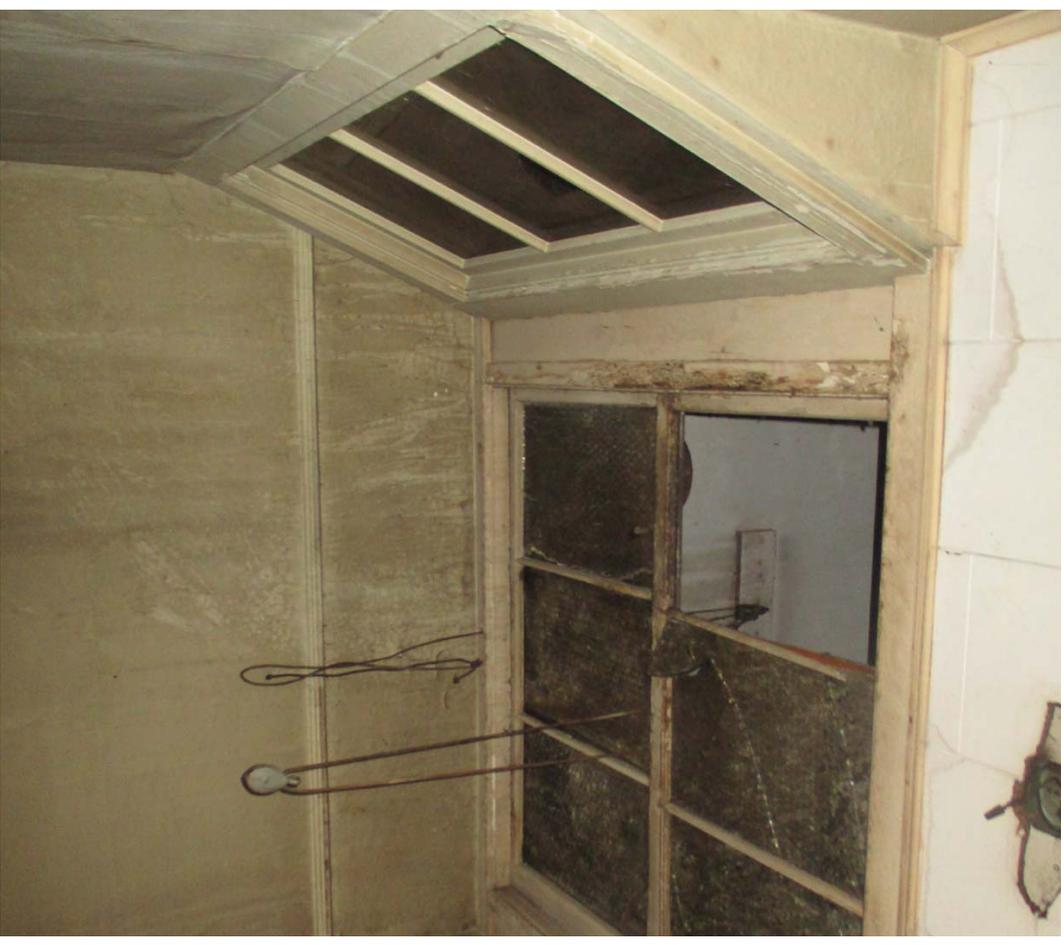
Damaged second story skylight.

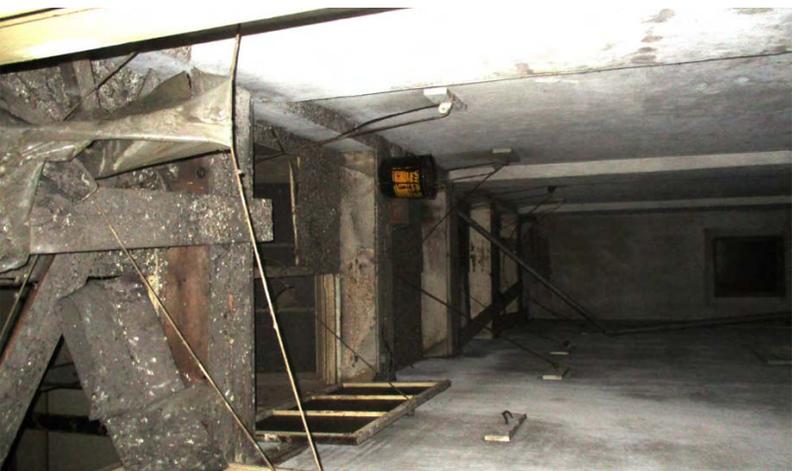
Existing second floor fire damage.

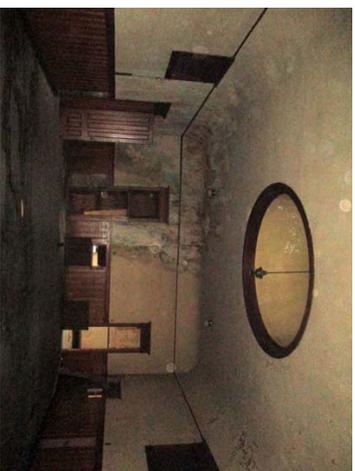
Water damage in the smaller auditorium space.

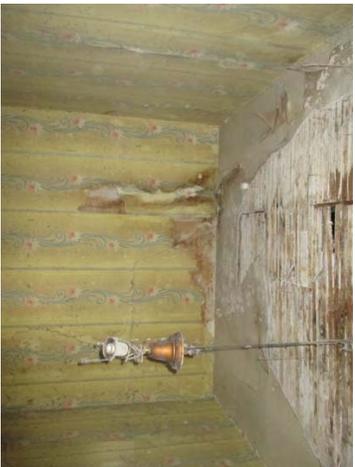
Existing second floor bedroom with damaged ceiling plaster:

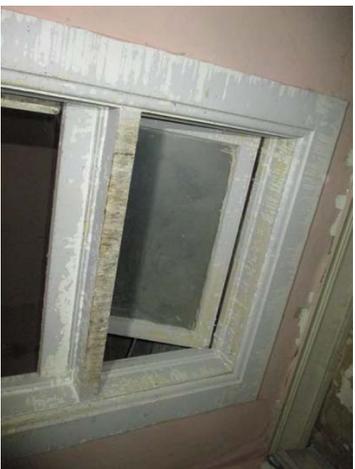
Interior transom windows used as an entry by pigeons:

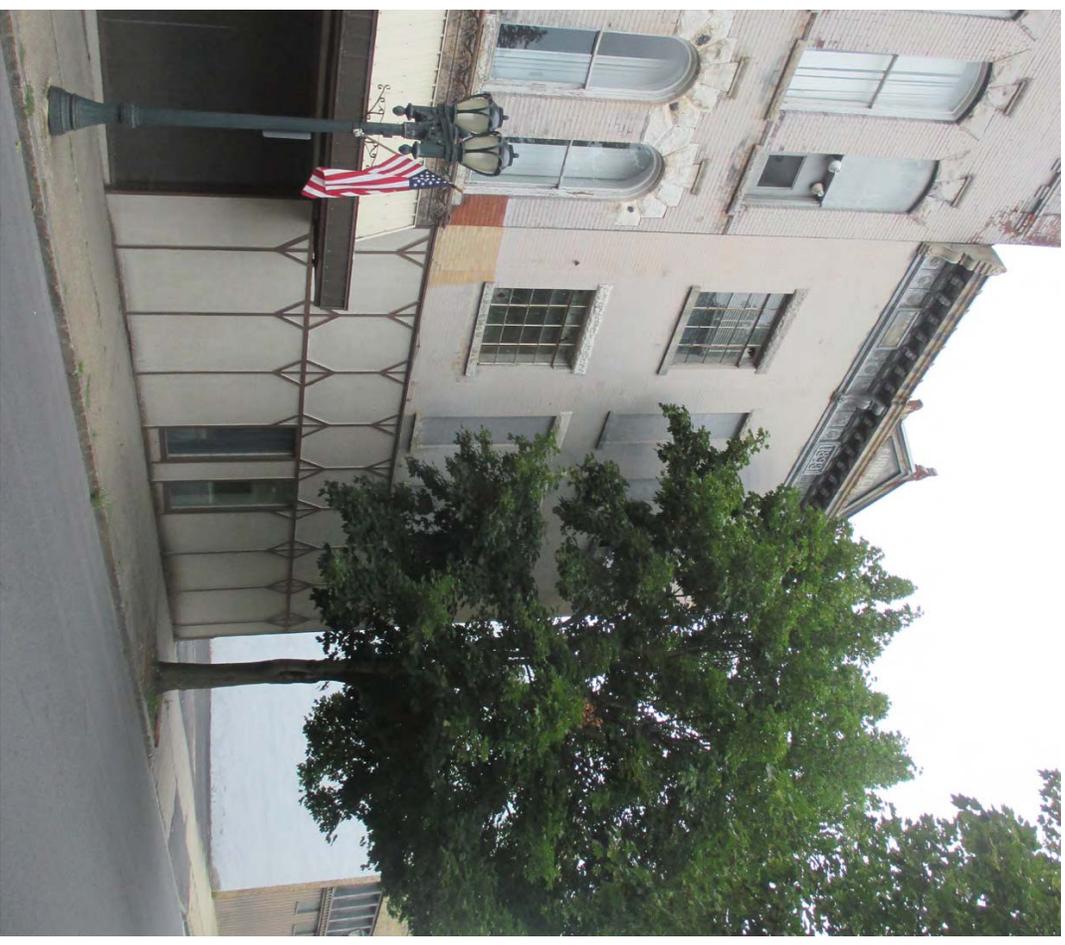
Current condition of facade with offices on the first floor to remain.

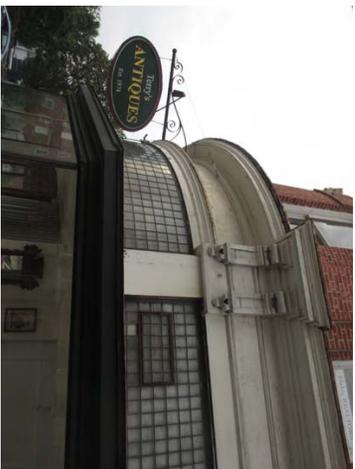
Existing cornice and transom details.

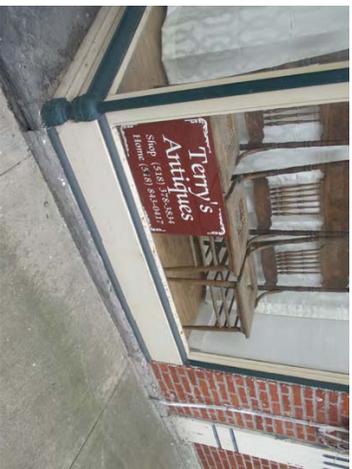
Exterior wood trim and knee wall on storefront.

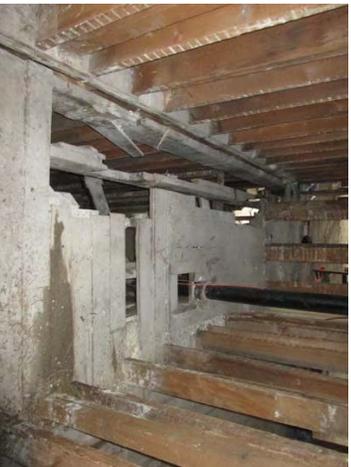
Evidence of past alterations/repair.

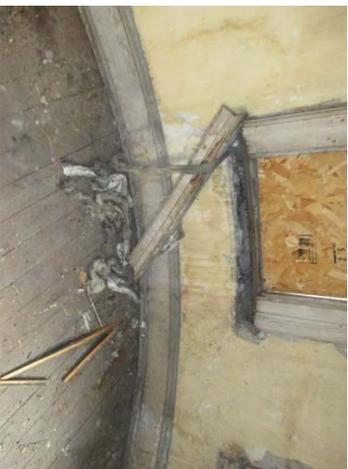
Damaged window sills on the interior second floor.

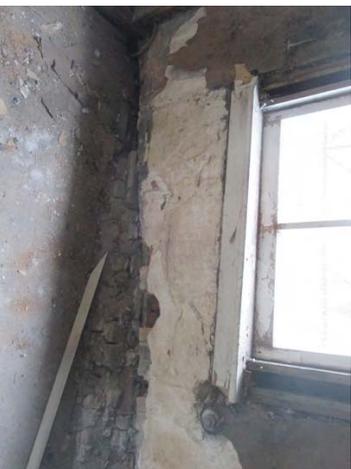
Evidence of repair/alteration work on the second floor.

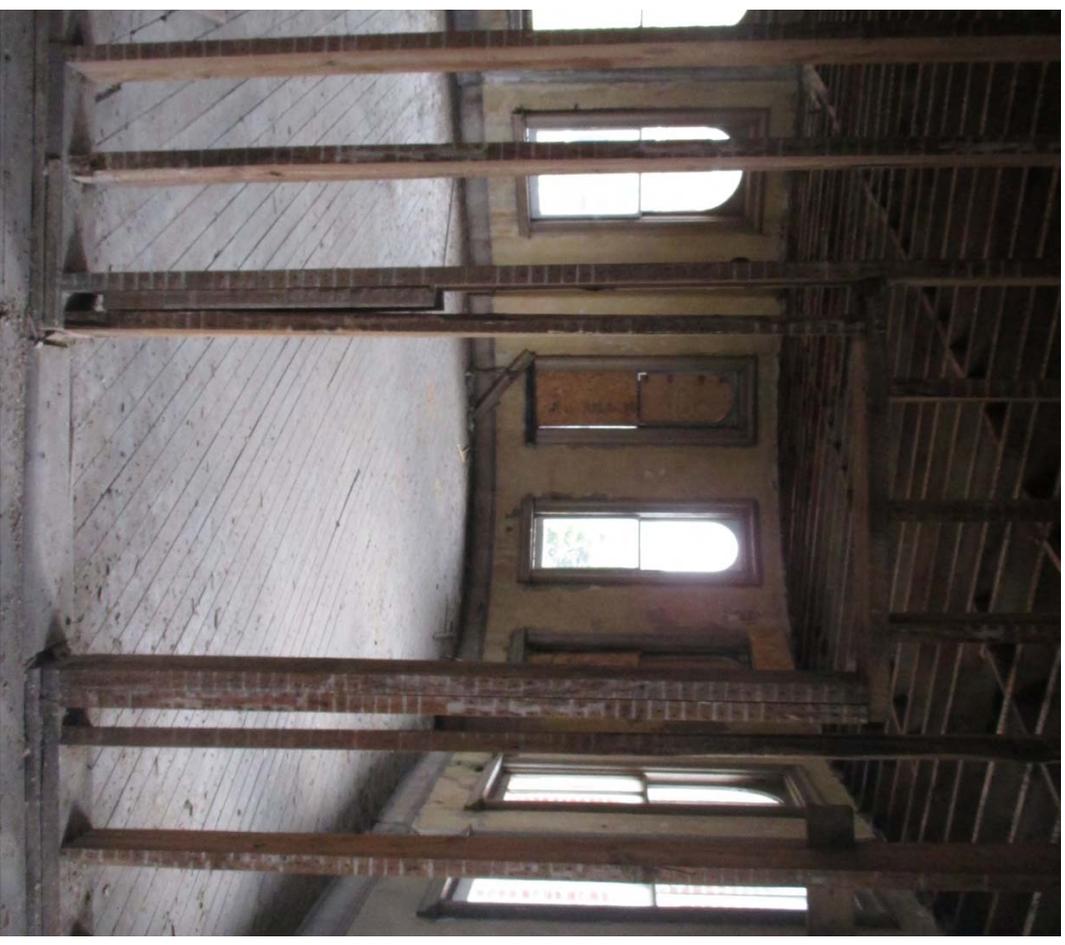
Typical interior conditions of the upper floors.
