City of Gloversville

Downtown Revitalization

Building Re-use Analyses

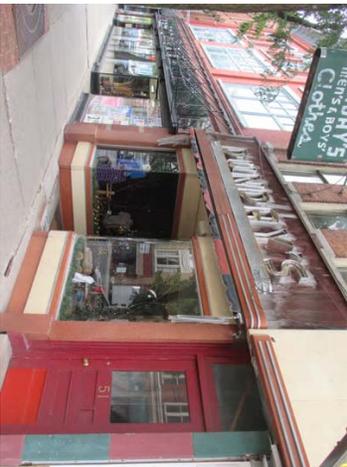
Remaining elements of historic signage

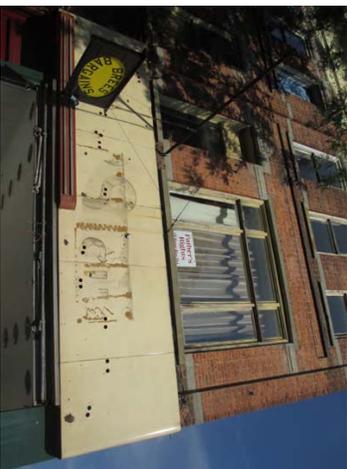
Remaining elements of historic signage

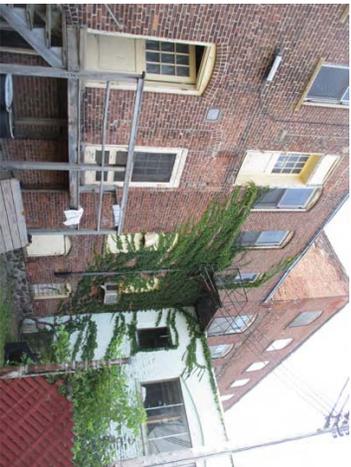
Rear exterior view.

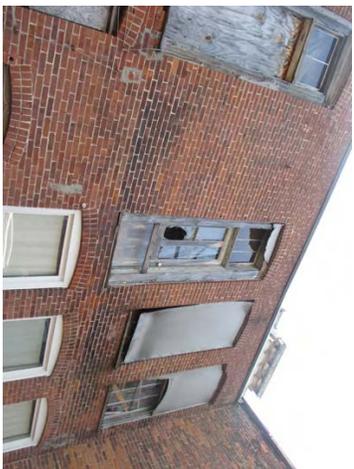
Existing rear facade (upper floor)

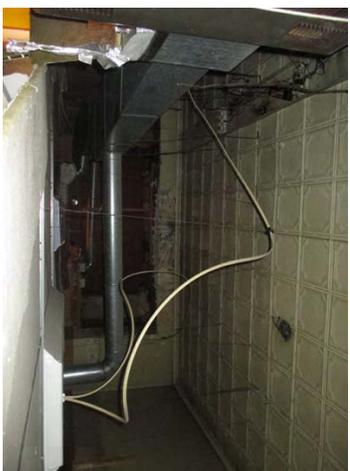
Existing first floor plenum space with original ceiling tile.

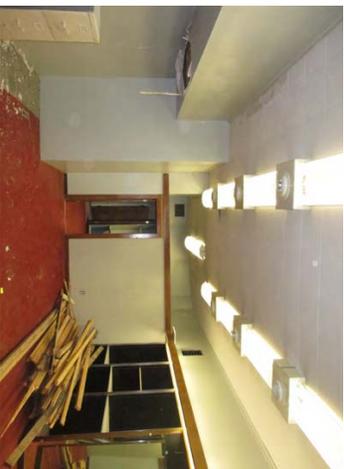
Existing interior of 51 North Main (construction in progress)

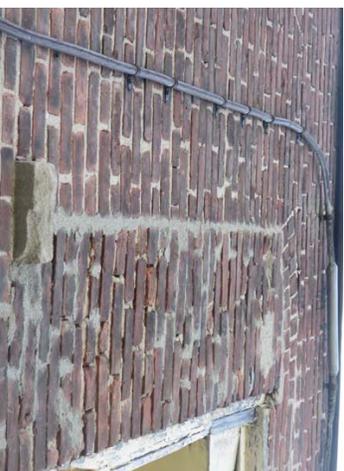
Signs of covered up masonry openings.

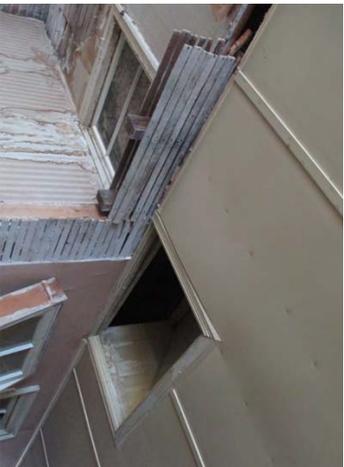
Existing upper floor skylights.

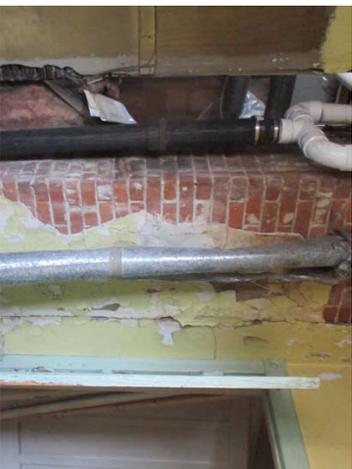
Existing Upper floor rear apartment finishes.

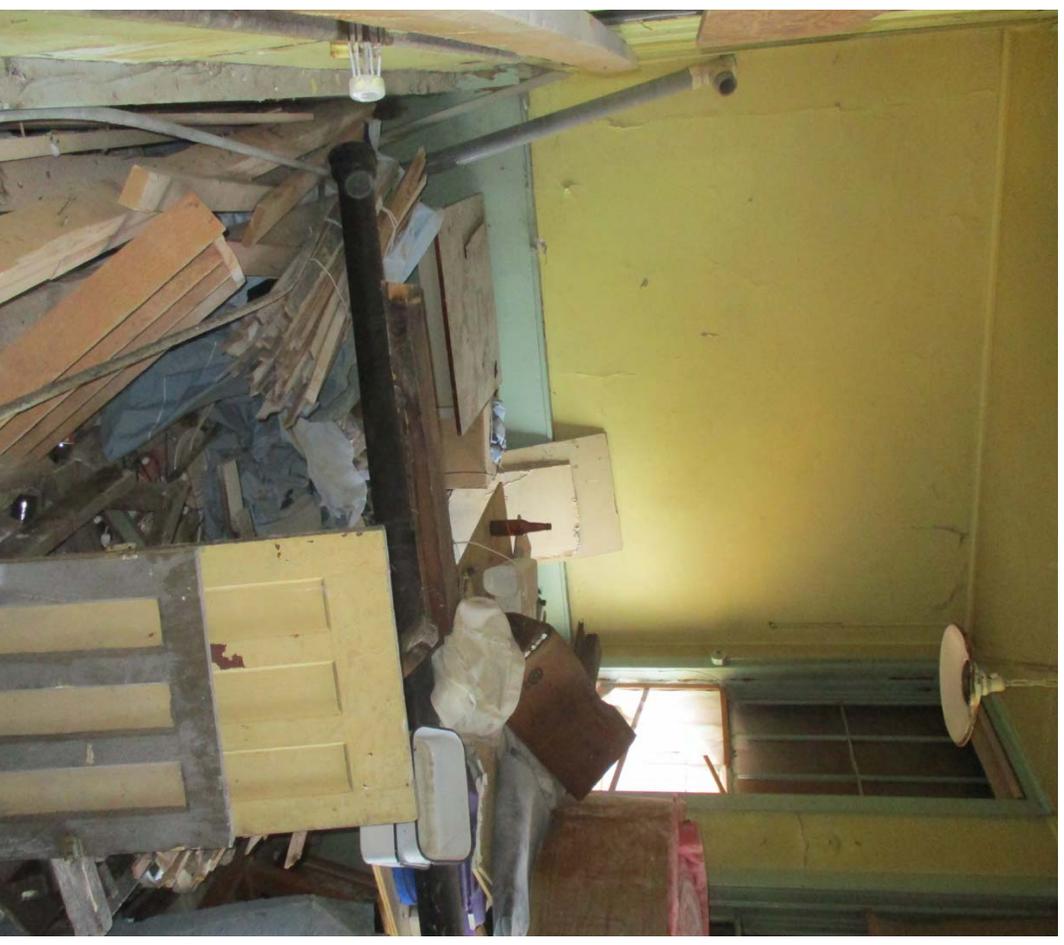
Upper floor rear apartments with existing finishes.

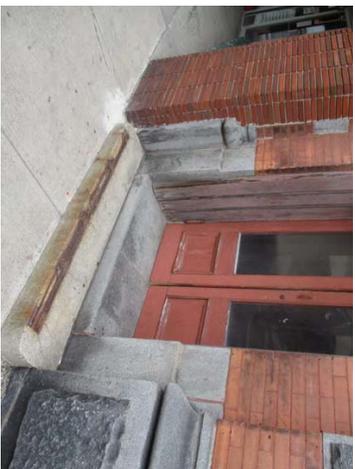
Existing upper floor entry with covered engaged columns.

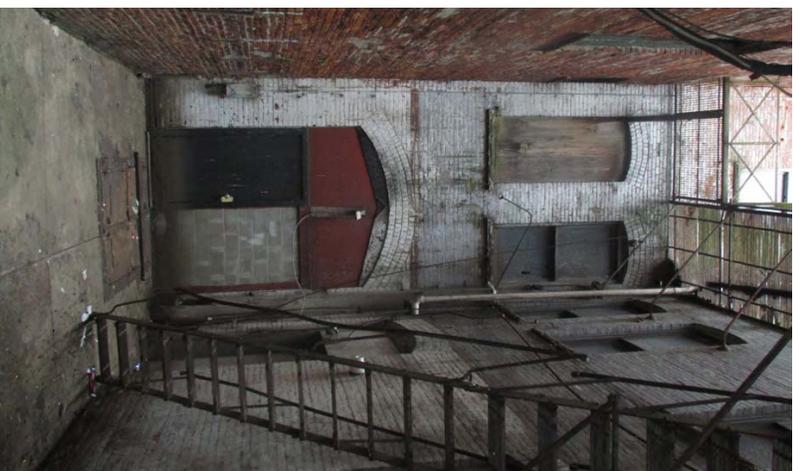
Existing rear alley with fire escapes

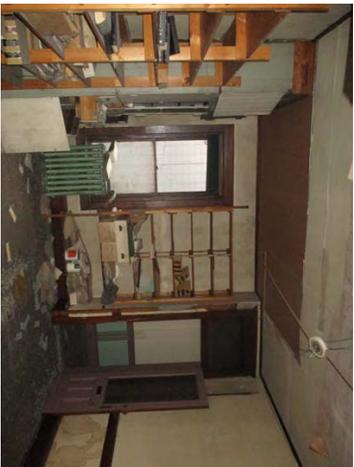
Rear second floor office with shelving.

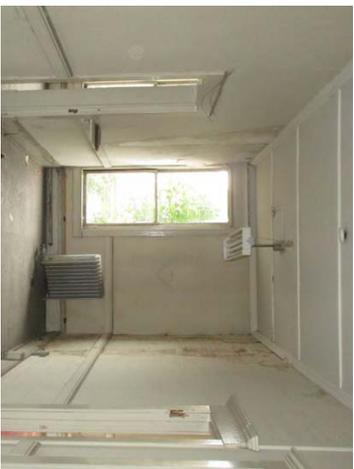
Existing second floor office hallway

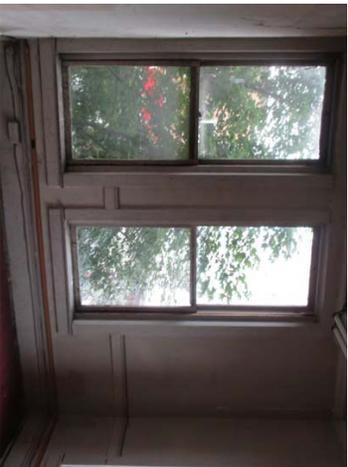
Existing second story windows.

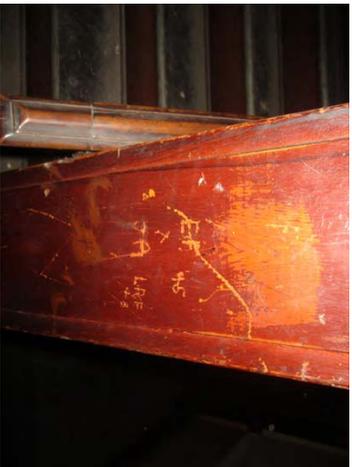
Graffiti with dates '45 and '48 on stair case.

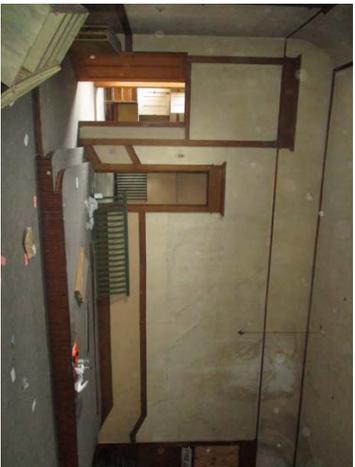
Stage area and adjacent rear rooms.

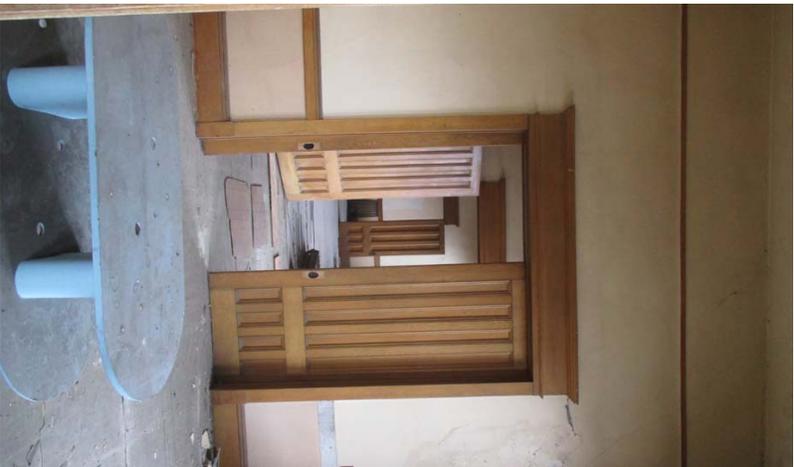
Pocket doors in the front portion of the Third Floor.

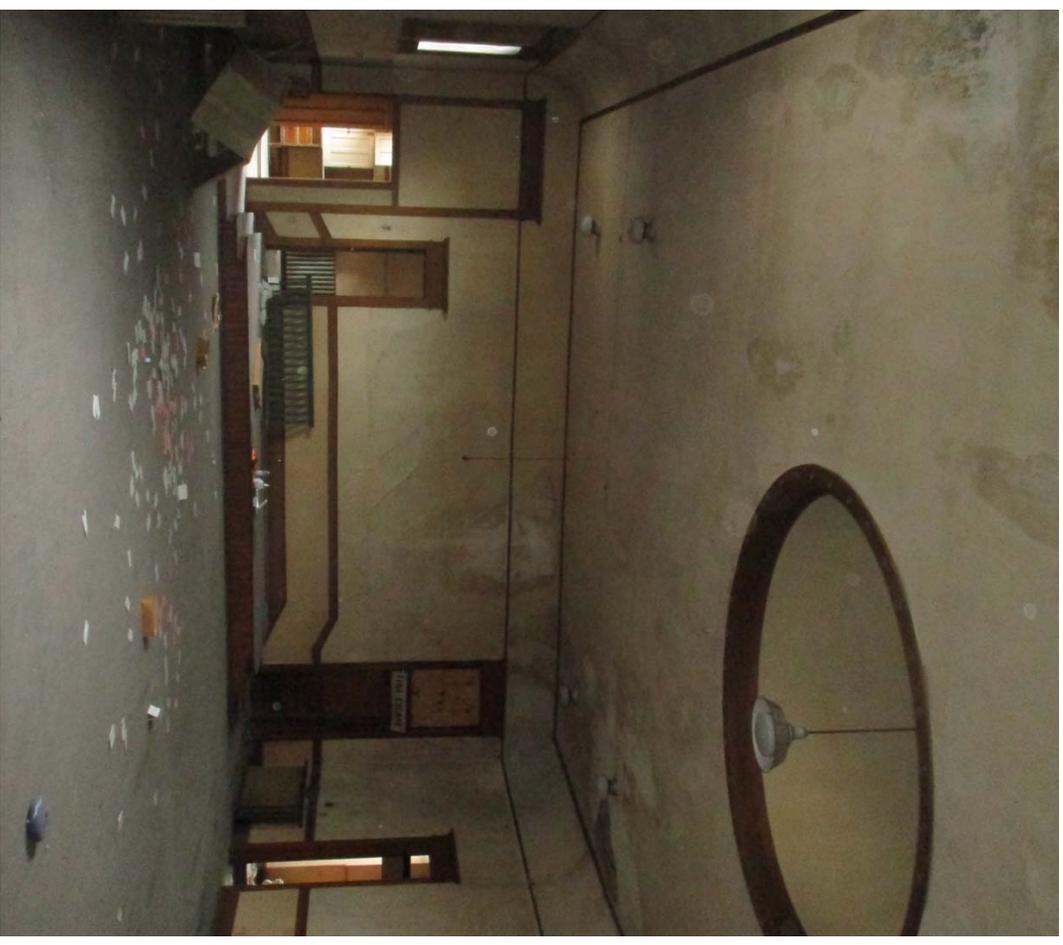
Larger 3rd floor auditorium space.

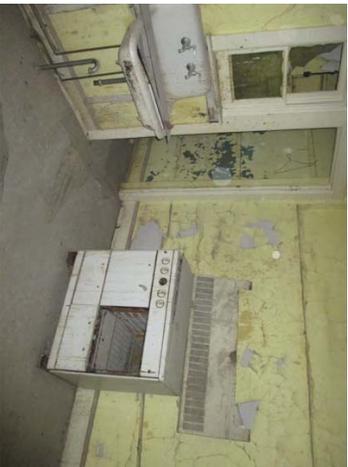
original fixtures in a second floor kitchen.

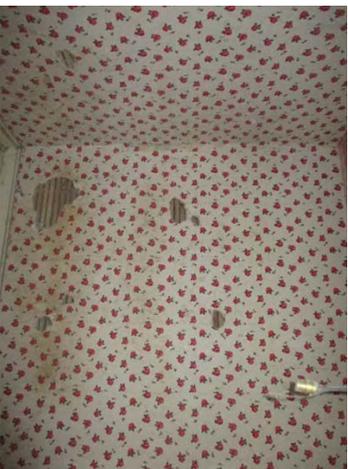
Existing wallpaper on lathe and plaster walls.

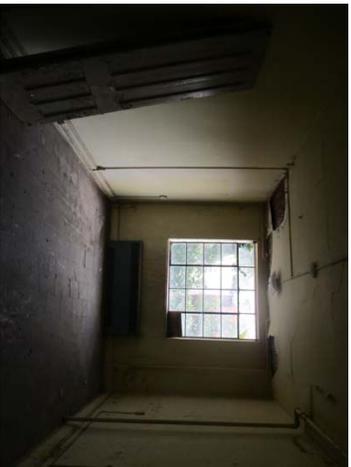
Second floor rear windows.

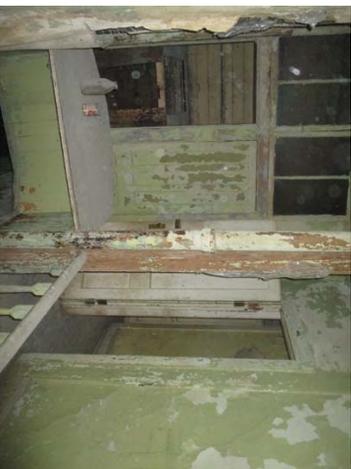
Third floor at stair case landing:

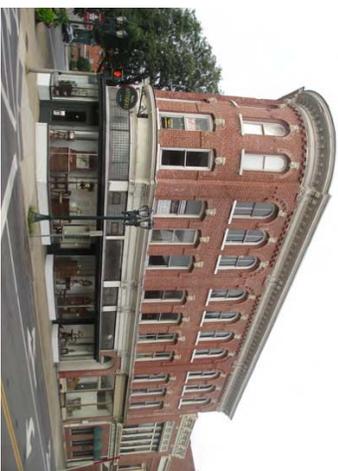
Exterior view.

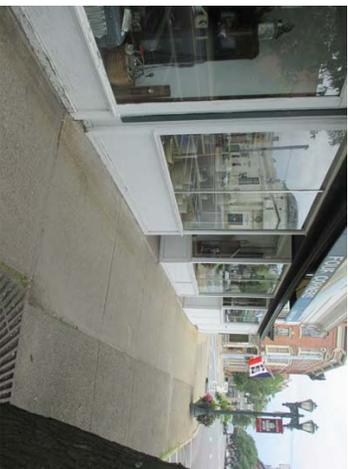
Existing storefronts.

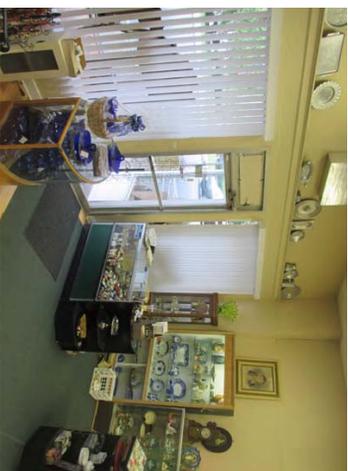
Typical commercial interior.

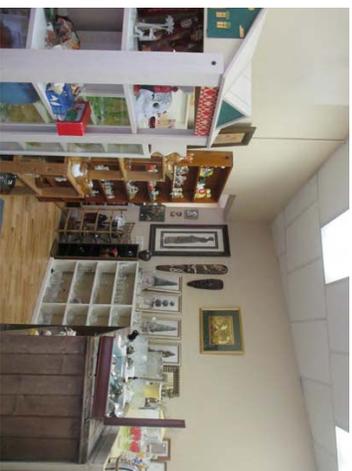
Typical commercial interior.

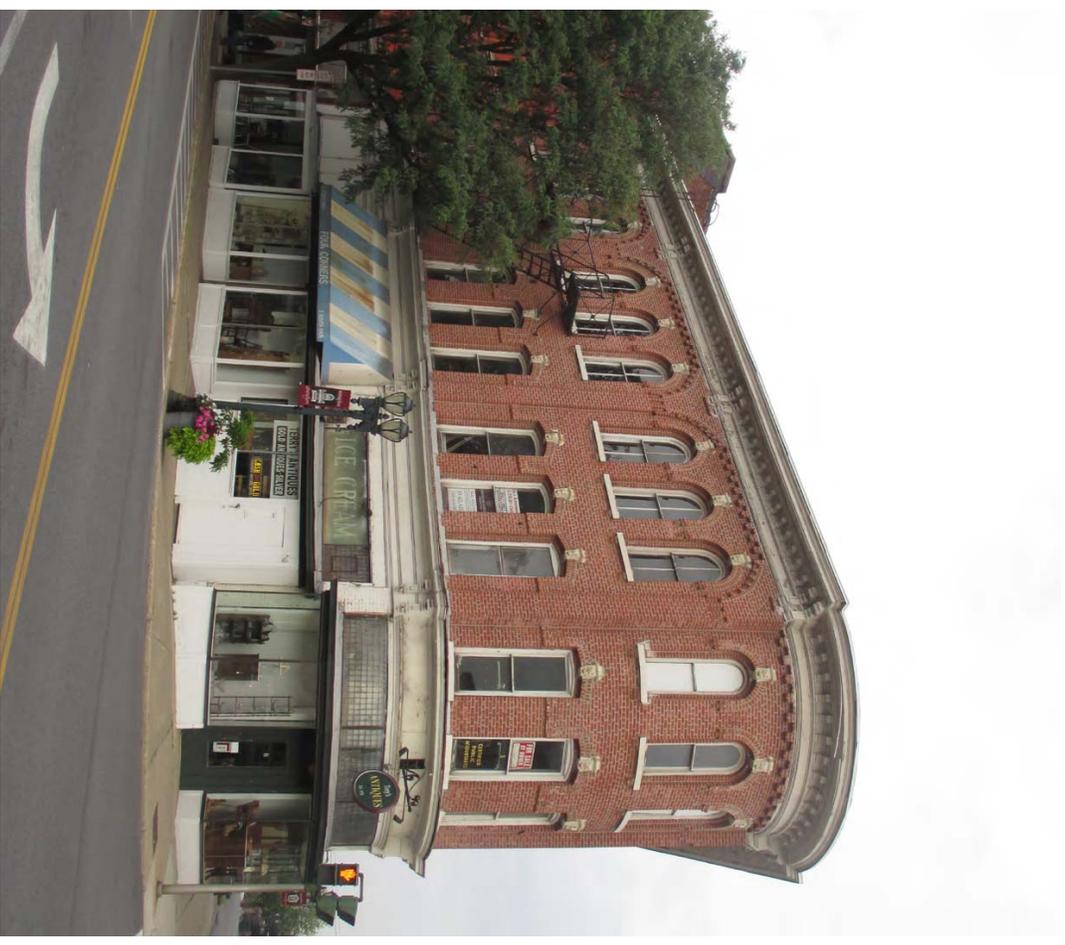
Exterior view.

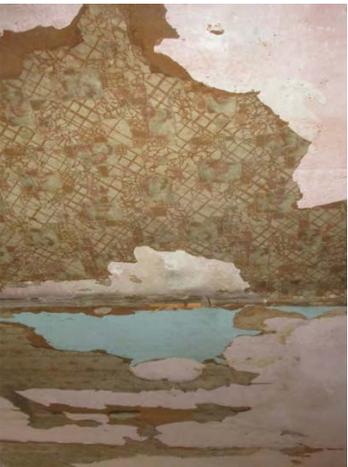
Layers of aged wallpaper on the upper floor interior.

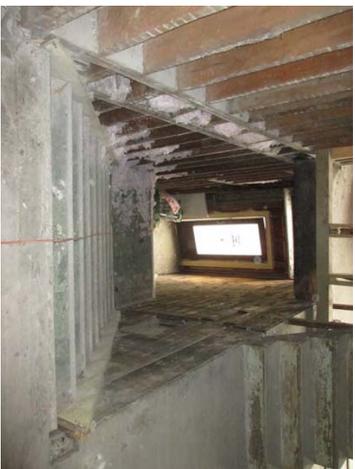
View from second to first floor.
